Sunnyside Cogeneration Associates

RE: Second Quarter 2006 Inspection Report
Star Point Refuse Pile C/007/042

IMPOUNDMENT INSPECTION AND CERTIFIED REPORT		Sediment Pond 005	
Permit Number	C/007/042	Report Date 7/25/06	
Mine Name	STAR POINT WASTE FUEL		
Company Name	SUNNYSIDE COGENERATION ASSOCIATES		
Impoundment Identification	Impoundment Name	Sediment Pond 005	
	Impoundment Number	005	
	UPDES Permit Number	UTG040025	
	MSHA ID Number	N/A	
IMPOUNDMENT INSPECTION			
Inspection Date	June 15, 2006		
Inspected By	Rusty Netz		
Reason for Inspection (Annual, Quarterly or Other Periodic Inspection, Critical Installation, or Completion of Construction)		Second Quarter Inspection 2006	
<p>1. Describe any appearance of any instability, structural weakness, or any other hazardous condition.</p> <p>NONE</p>			
Required for an impoundment which functions as a SEDIMENTATION POND.	<p>2. Sediment storage capacity, including elevation of 60% and 100% sediment storage volumes, and, estimated average elevation of existing sediment.</p> <p>Total Pond volume = 6.96 acre-feet</p> <p>Sediment Storage Capacity = 2.42 acre-feet Pond bottom elevation = 7387.3 60% sediment elevation = 7393 Maximum Sediment D

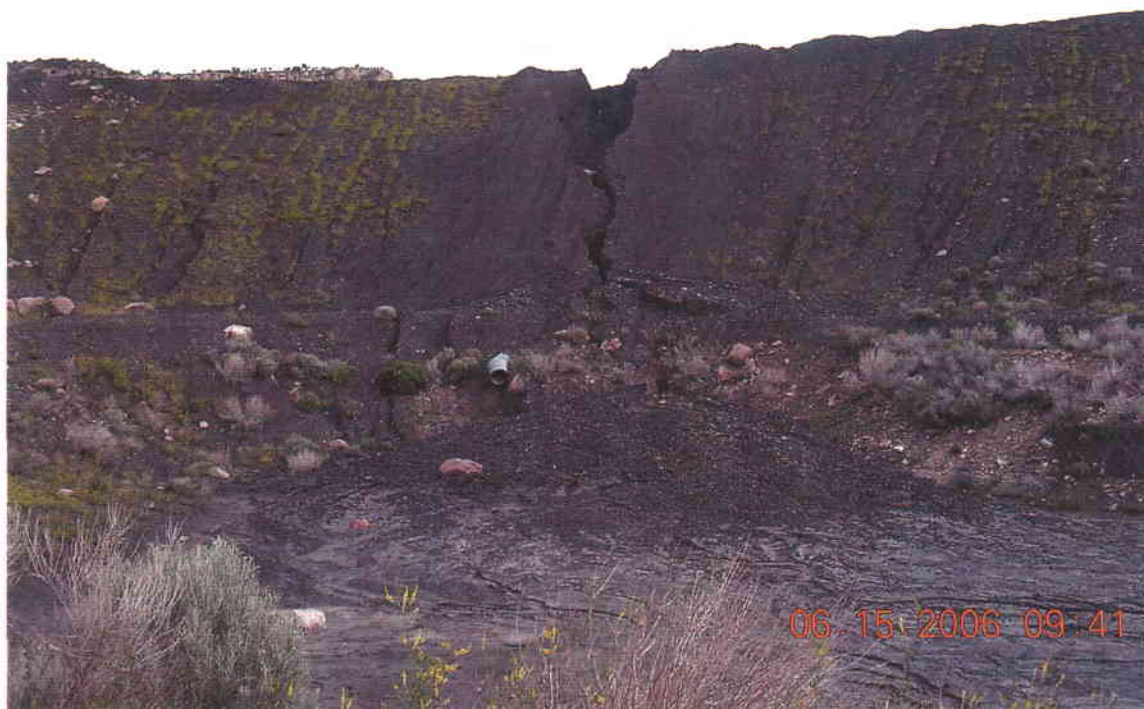
There was a culvert on the side of the pile that washed out and contributed a significant amount of sediment into the pond below. The culvert was repaired and the area restored. See attached pictures of the conditions before and during the repairs.

South Side of Coarse Refuse Pile (Pond 005 in foreground)

June 15, 2006

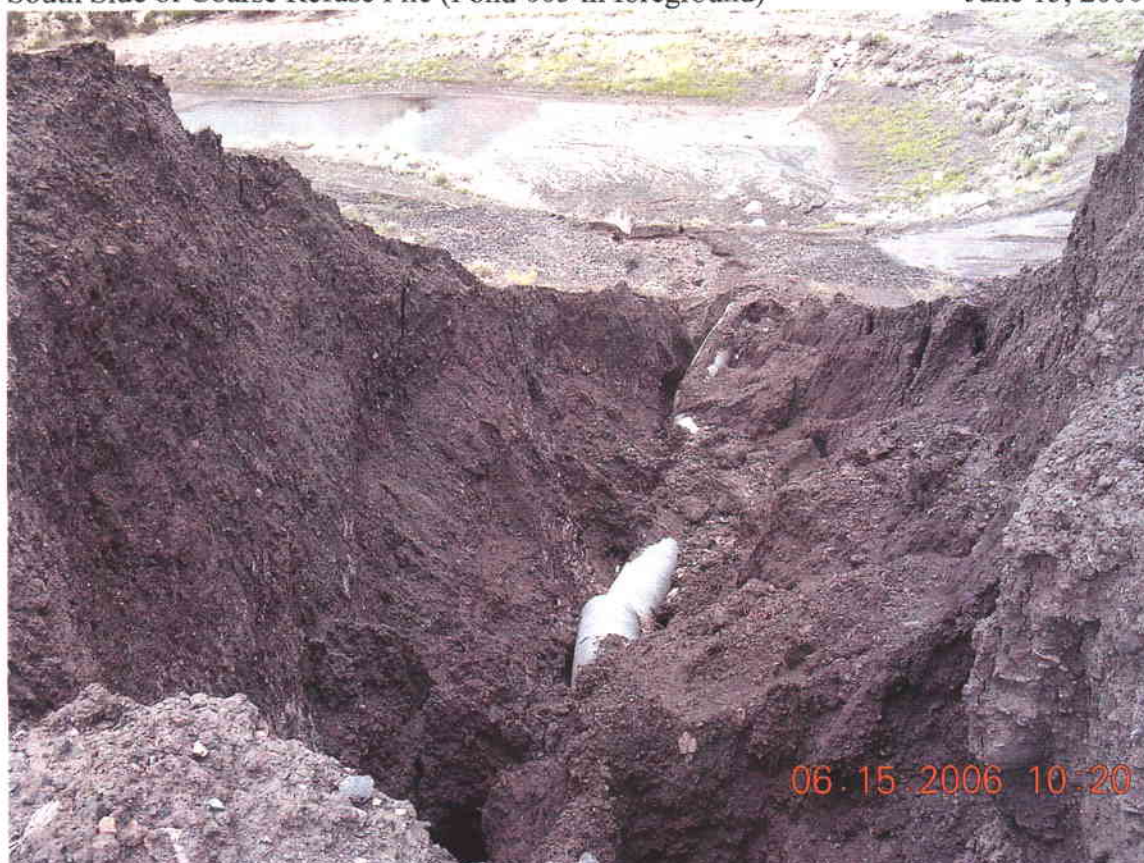
No structure or stability problems observed with the pond. There was a culvert above the pond which washed out and contributed a significant amount of sediment into the pond. The culvert was repaired and the area restored. See pictures attached with the Coarse Refuse Pile inspection report.

From top of refuse pile looking down culvert alignment towards Pond 005 June 15, 2006

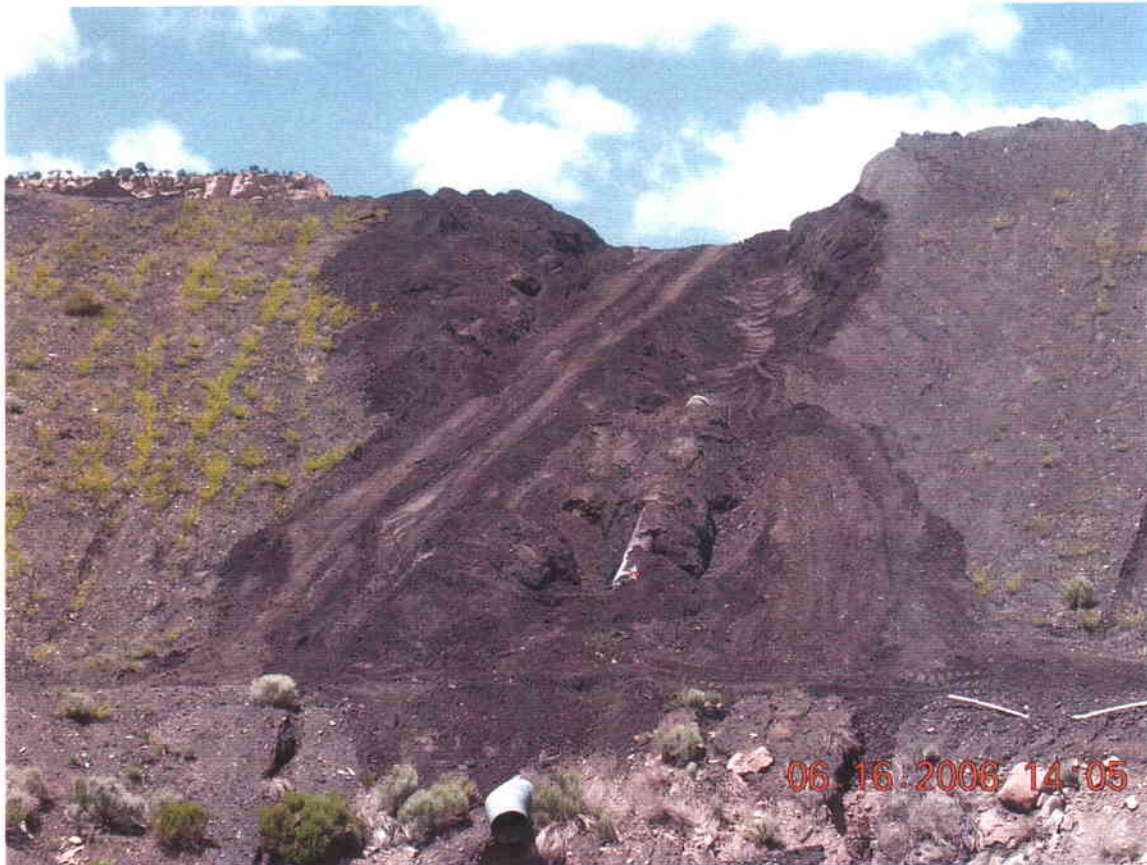
Looking at culvert and slope repairs in progress

June 16, 2006
